Thermology and Inspection Report For

ORDER NO: xxxxx
PROPERTY ADDRESS: xxxxxxxx
DATE OF INSPECTION: 14 August 2009

Investigate leak above lounge room in downstairs of residence.

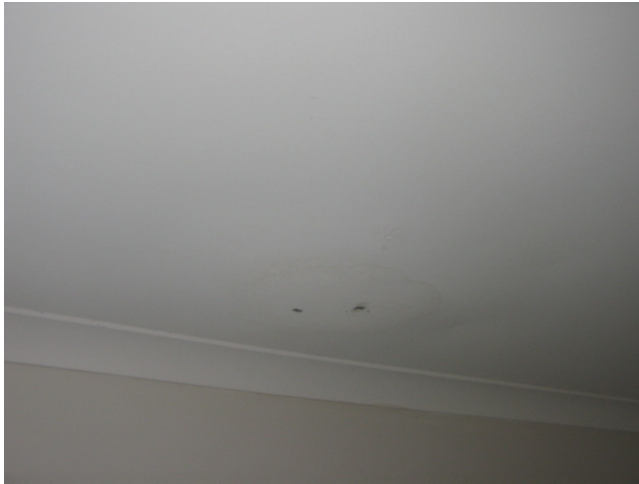
As per the picture below (picture one) there are water marks on the ceiling in the down stairs lounge room. Directly above the rear is a bathroom that has been previously tested for water leaks by others and nothing has been found. The two holes in the ceiling are drain holes made by the tenants to let water build-up out of the ceiling after the last big rain event.

Picture 1 - ceiling of downstairs lounge room

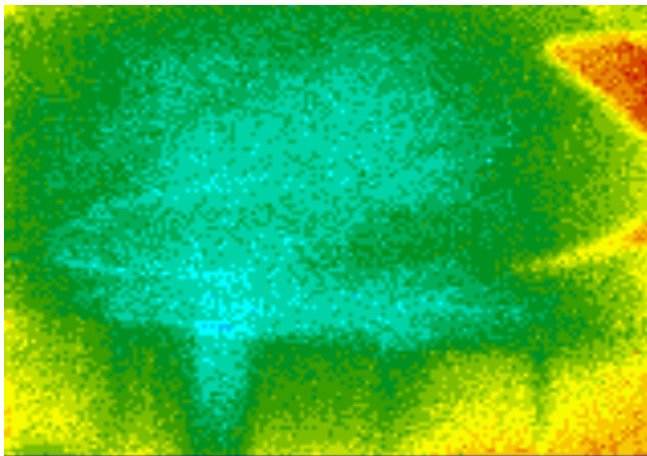
Thermal picture 1 - ceiling of downstairs lounge room

As per the thermal picture above there is no moisture in the ceiling prior to testing. From this we can safely say that there is no water ingress occurring from the bathroom and plumbing above.

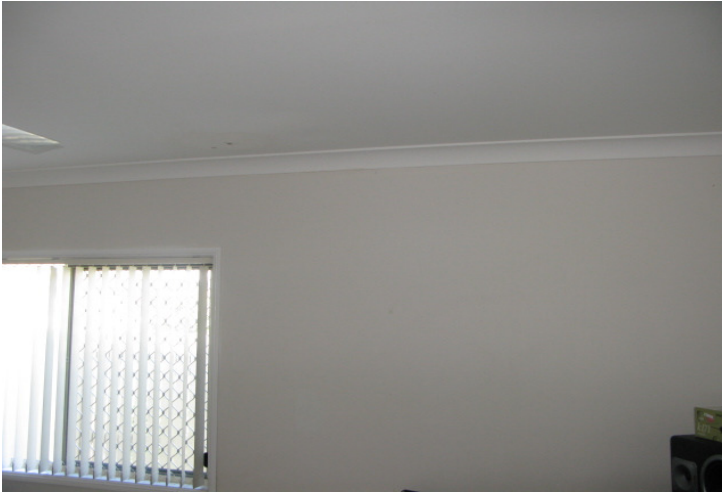
Picture 2- side wall of lounge room in the lower-level

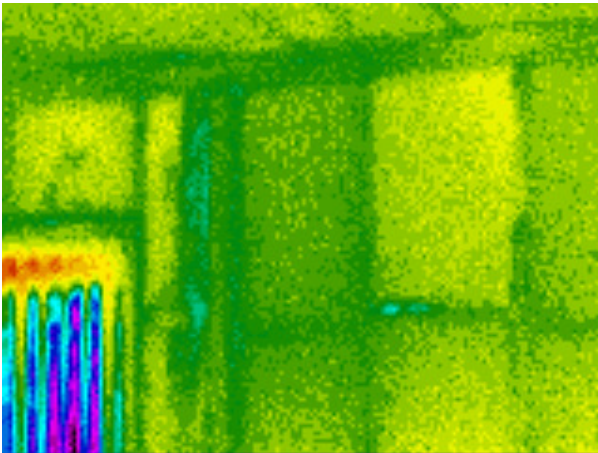
Thermal picture 2 - side wall of lounge room after spray testing

When the outside western wall was spray tested with water spray, there was significant water ingress in between the weatherboard and the internal plasterboard which shows up in the thermal pictures above.

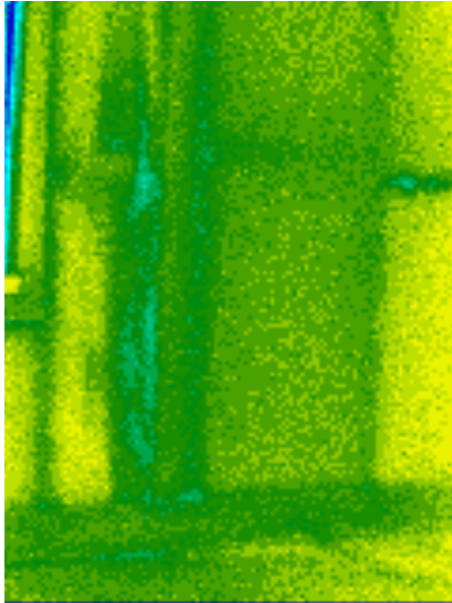
Thermal picture 3 - side wall of lounge room after testing

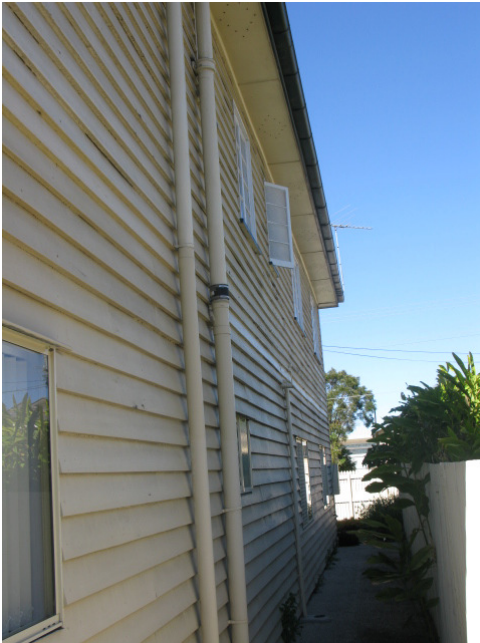
Picture 3 - external photo of the side wall on western side - the bathroom windows can be seen above the lounge room ceiling area where the damage is.

With the severe weather events that have been occurring, this entire western wall would be well exposed to harsh wind driven rain. The water would track down in the wall where it would have accumulated in the ceiling space causing the water damage.

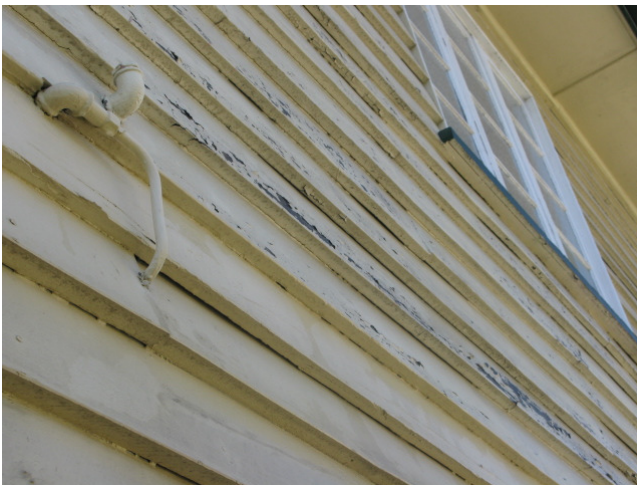
The weatherboards have large gaps at the base of the boards which allows water to be blown in behind the boards causing damage to the plaster ceilings and sidewalls. The base of the window sills in the side of the window are also susceptible to leaks in a severe storm event.

Picture 6 (above) – this shows the many large gaps in the weatherboard where they join; this is also the same around the window sills as shown.

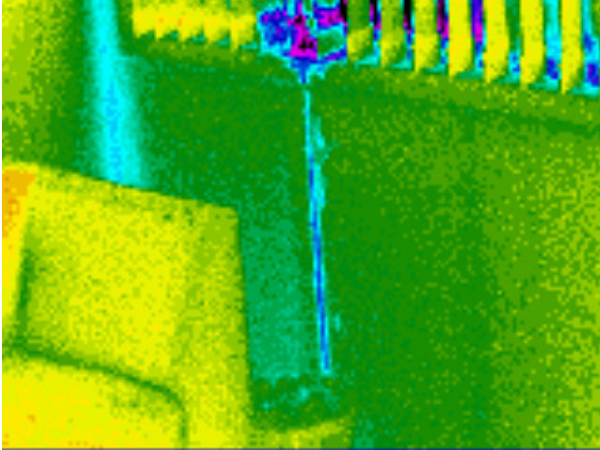
Thermal picture 7 - water ingress at base of window sill after spray testing - this water was dripping from the window head above as you can see.
